# **OPERATING EXPERIENCE WEEKLY SUMMARY**

**Office of Nuclear and Facility Safety**

**August 20 - August 26, 1999**

**Summary 99-34**

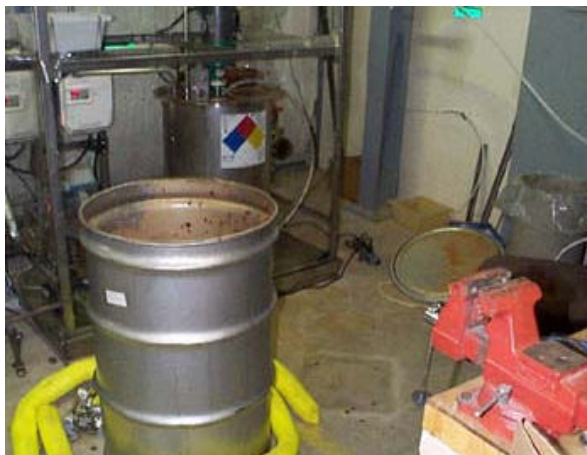
On August 13, 1999, at the Savannah River Technology Center, an engineer participating in a research project received a laceration to the forehead when he was struck by a lid propelled from a pressurized drum. He and a technician were pumping approximately 30 gallons of sludge from an experimental tank to a nearby 55-gallon drum, using a positive displacement pump, when he noticed that the flow had stopped. Workers had installed a valve and pipe on the side of the drum near the bottom for the sludge transfer. They left the lid on the drum to eliminate splashing during the transfer. The engineer shut the pump off and determined that the pump had pressurized the drum to 15-20 psig. The lid propelled from the drum as he attempted to release pressure by loosening the locking ring. Figure 1-1 shows the experimental equipment and the final resting place of the lid. The sludge had a pH of approximately 5 and contained traces of mercury. Responders transported the injured employee to the site medical facility, then to a local hospital, and from there to a plastic surgeon who closed the wound. This event is significant because the sudden release of pressure from pressurized drums can cause severe personal injury, expose personnel to contamination, or release hazardous or toxic contents to the environment. (ORPS Report SR--WSRC-LTA-1999-0030)

**Figure 1-1. Drum and Propelled Lid**

To prevent similar occurrences, facility managers plan to (1) review and revise the job hazard analysis and procedures for the experimental process and drum handling, (2) evaluate the need for task-specific briefings, (3) issue a lessons learned bulletin on this occurrence and issue a safety bulletin to research personnel, and (4) establish policy guidance to endorse willingness to stop work.

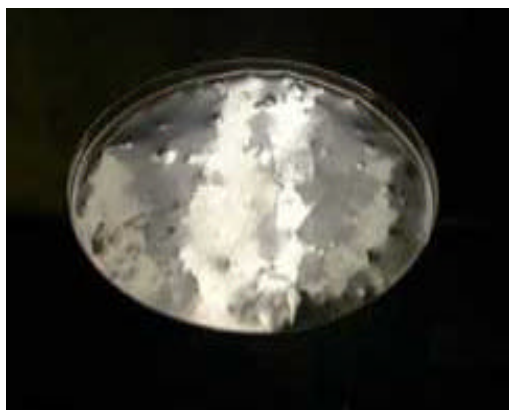
Investigators determined that approximately seven weeks ago operations personnel repackaged several plutonium buttons and prepared them for shipment to Los Alamos National Laboratory for further disposition. Because the shipment was full, four of the cans could not be shipped, so operations personnel stored them in accordance with procedures. Investigators determined that the site plutonium transfer and storage procedure required operators to re-open the four remaining cans after 30 days of storage, brush any oxide off the buttons, and repackage them for long-term storage. Operators completed the repackaging operation on about August 5. Investigators determined that when operations personnel opened the outermost cans, they saw the damaged inner cans and noticed that the lids were partially lifted upward (approximately one-quarter of an inch). They reported the condition and notified Los Alamos personnel to inspect the shipment for additional damaged cans. Figures 3-1 and 3-2 show the damaged cans.

**Figure 3-1. Damaged Can – Bottom View**

The facility manager directed technical support personnel to investigate further. They will re-open the repackaged material cans to determine what configuration the plutonium is in and will examine similar packaged items. They will also conduct a repackaging/handling experiment to attempt to reproduce the damage. Los Alamos personnel will determine if any of the cans they received from the Rocky Flats Technology Site exhibit the same type of damage. The facility manager will develop corrective actions when technical support personnel have completed their investigation.

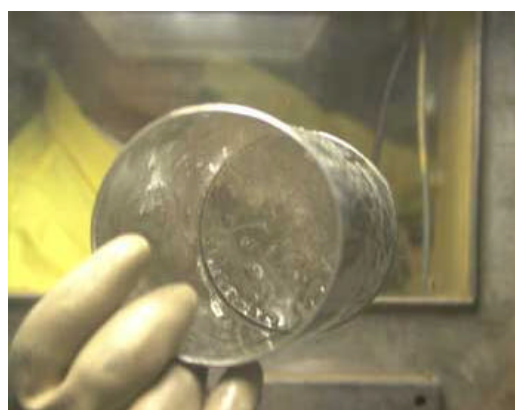
**Figure 3-2. Damaged Can – Inside View**

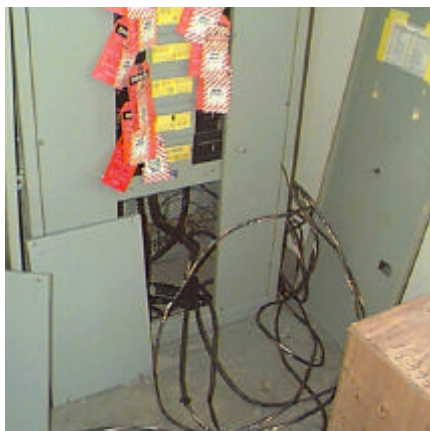
On June 14, 1999, at the Strategic Petroleum Reserves Big Hill Site, a subcontractor laborer looking for a cable identification tag inside a power distribution center panel inadvertently touched her head on two 480-V bus bars and received a severe electrical shock. She was unable to free herself from the electrical source, so an electrical helper kicked her hip until she was dislodged. A nearby field operator and a pipe foreman saw the event and immediately notified the operations control center to initiate an emergency electrical shut-off to the building and notify the site emergency response team. Emergency help air-lifted the laborer to an area hospital, where she was treated for third-degree burns. Investigators determined that neither a safe work permit nor a lockout/tagout was issued for this work and the laborer was not adequately trained to perform work near energized equipment. (ORPS Report HQ--SPR-BH-1999-0004)

**Figure 1-1. Electrical Distribution Panel**

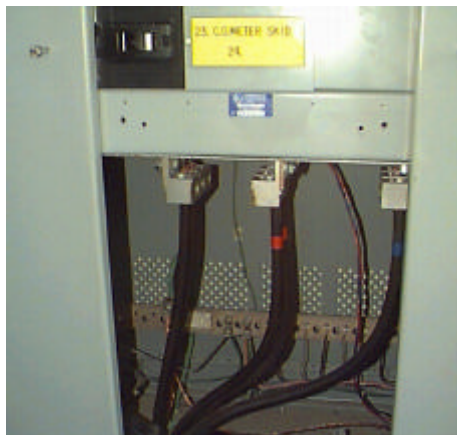
Three subcontractor workers (an electrical journeyman, an electrical helper, and a laborer) were preparing previously run electrical cables for upcoming testing and termination by removing electrical insulation from wire conductors. The journeyman removed the covers from two distribution panels to locate the cables and remove the insulation while his co-workers removed insulation from previously run wiring in nearby, de-energized panels. The journeyman noticed that the panels he opened were energized, but he did not tell his co-workers and did not perform a lockout/tagout. The journeyman removed the insulation, closed the panel covers, and prepared to leave the area. As he was leaving, the electrical helper told him that he believed that there was still one cable in the panel the journeyman had worked on that needed to have insulation removed. The two briefly discussed the remaining cable-stripping task, and the journeyman left the area, leaving the helper and the laborer to finish the task. The electrical helper removed the cover of the energized power distribution panel, located the remaining cable, and began removing the insulation. He noticed that the identification tag was missing from the cable and asked the laborer to look inside the open panel cover and search for the tag. While looking for the identification tag, the helper inadvertently made contact with the energized 480-V bus bars. Figure 1-1 shows the electrical distribution panel. Figure 1-2 shows the 480-V bus bars.

**Figure 1-2. Bus Bars**
